## Short communication

## A ring area formed around the erosion pit on 1Cr18Ni9Ti stainless steel surface in incipient cavitation erosion

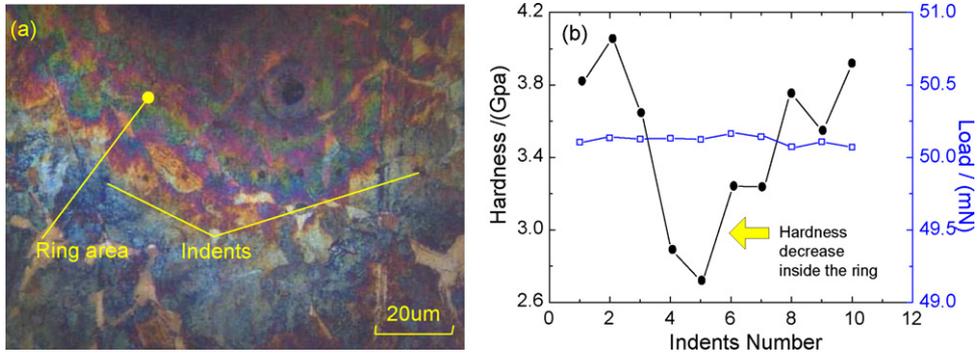
Fig. 3. Surface hardness testing, (a) is the pit with indents, (b) is the hardness in and outside the ring.

The hardness of the damaged surface shown in Fig. 2 was tested by a Nano Tester (MML Co.). 10 indents were made on the sample surface along the radius direction, which are shown in Fig. 3(a). The interval between the indents is 10 μm, and the maximum load was 50 mN. The hardness data of the surface within and outside the ring area is shown in Fig. 3(b). It is found that the mean value of the hardness inside the ring is obviously lower than that outside the ring. Also, obvious plastic deformations were seen around the indents inside the ring, while the edge of the triangle shape of the indent outside of the ring is clear. Moreover, as shown in Fig. 2 and Fig. 3(a), the ring is colorful and the color of the surface within the ring changes from red to blue gradually. The appearance of the iridescent color indicates that the temperature on the steel surface may reach 300 °C according to Wang's experiment [10]. On the other hand, it is known that the hardness of the steel decreases when the steel is tempered under the temperature higher than 300 °C. So, the iridescent color and the decreased surface hardness both indicate that the ring area has experienced a high temperature tempering process.
